As an improvement program by Archeological Survey of India (ASI), Hyderabad, the Director of ASI decided to take the support of latest technology such as LiDAR Scanning to support their on-going digitization and documentation project. As a result of this, on 6th April, Director instructed Ansari Precision Instruments Private Limited (**APIPL**) team to conduct a pilot **LiDAR** scanning of 11th Century Kakatiya temple in Karimnagar, AP. Accordingly, APIPL team conducted the LASER Scanning on 12/13 and 14th of April under the supervision of Archeological Survey of India and Deccan Heritage Foundation (**DHF**) team. To prove the usability of Laser Scanner in ASI's workflow, APIPL executed this scanning project at own cost.

Kakatiya Temple

Samples of Kakatiya LiDAR Scanning

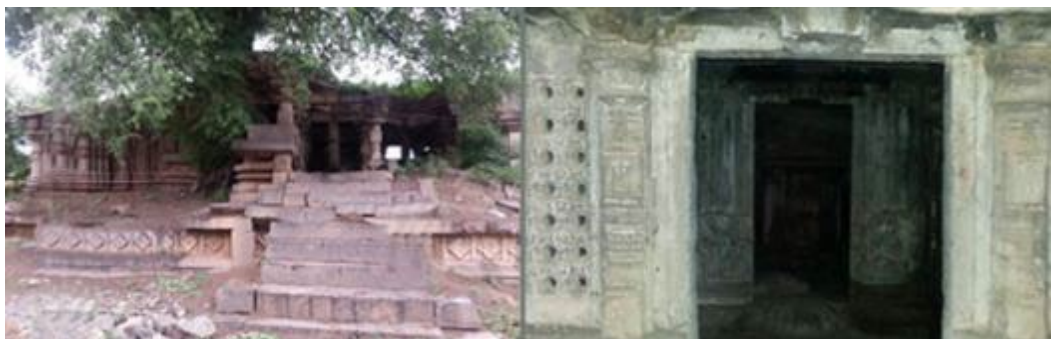
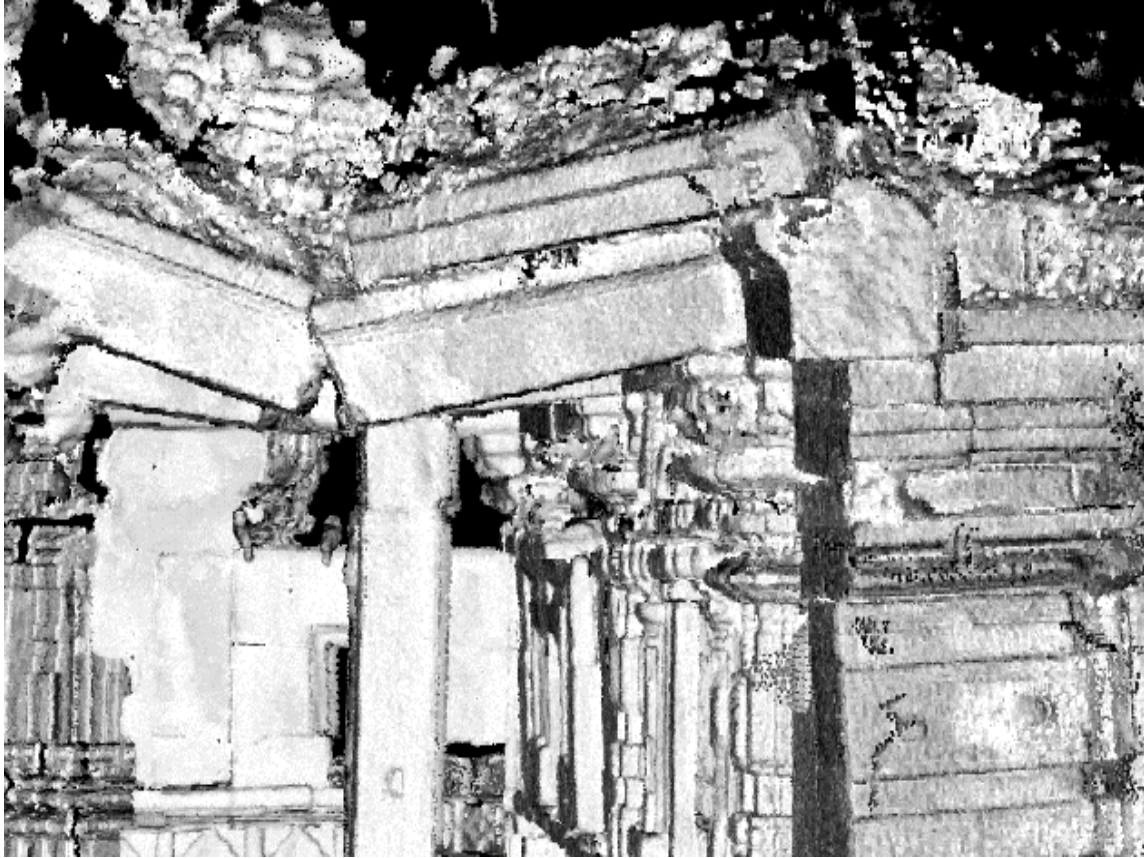
Point cloud which is measurable and to scale

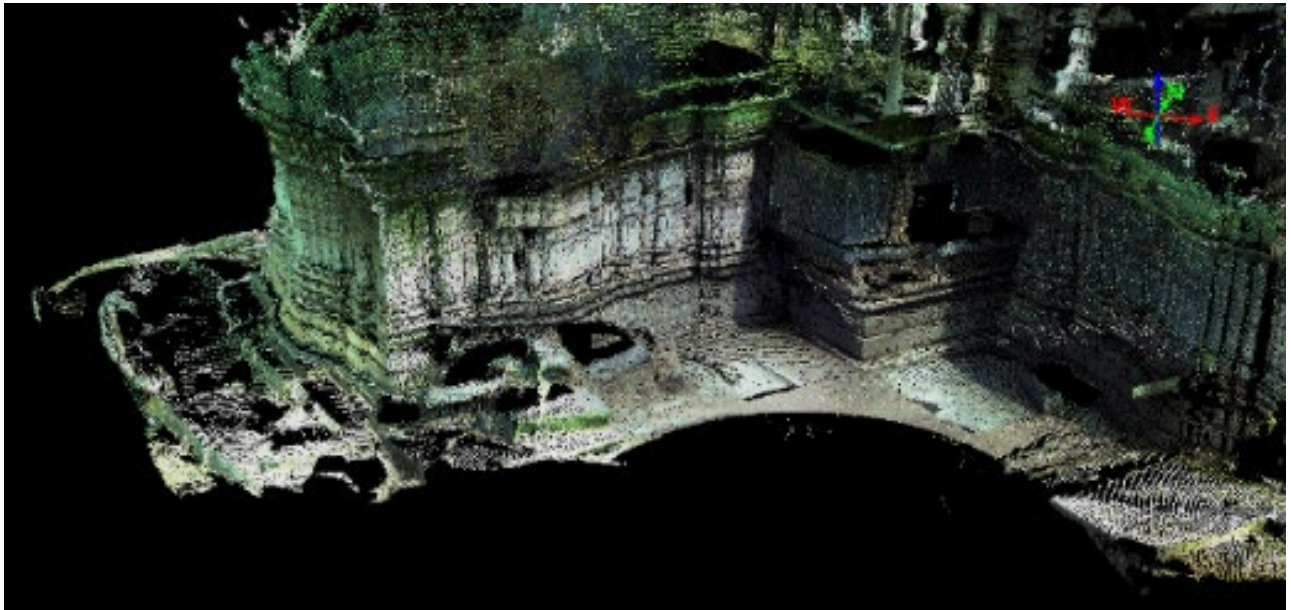
Isometric View

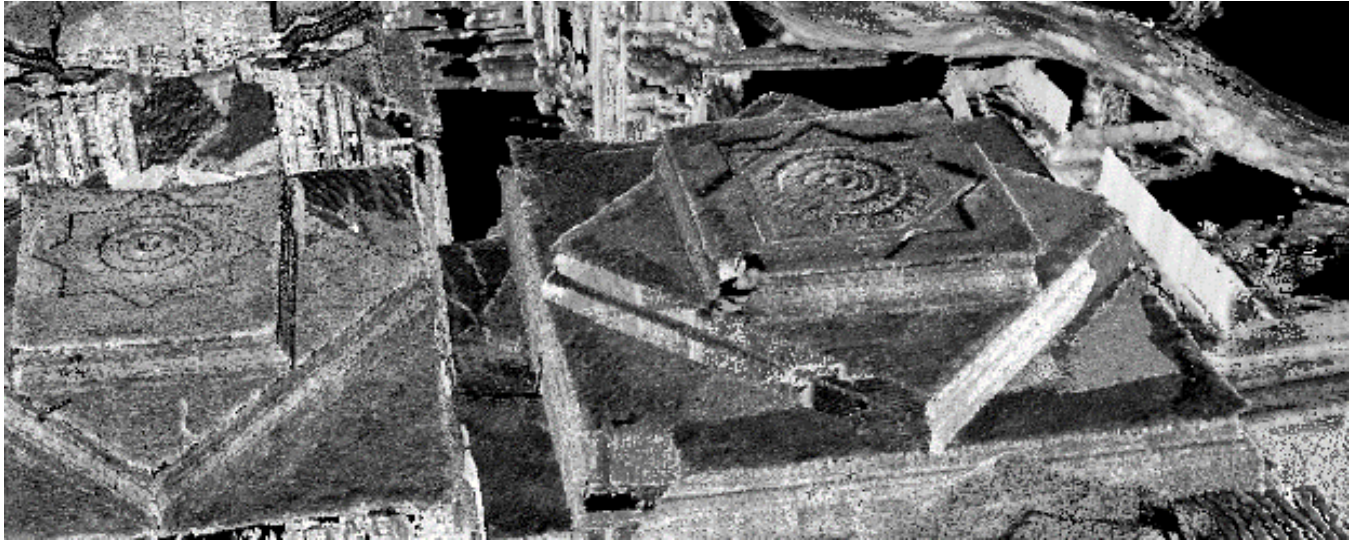
Interiors of chambers (roof), accurately scanned by scanner which cannot be mapped by any other means.

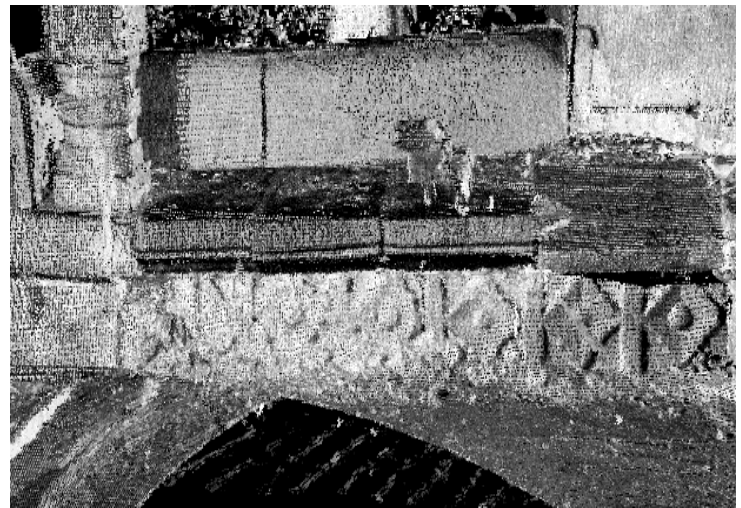
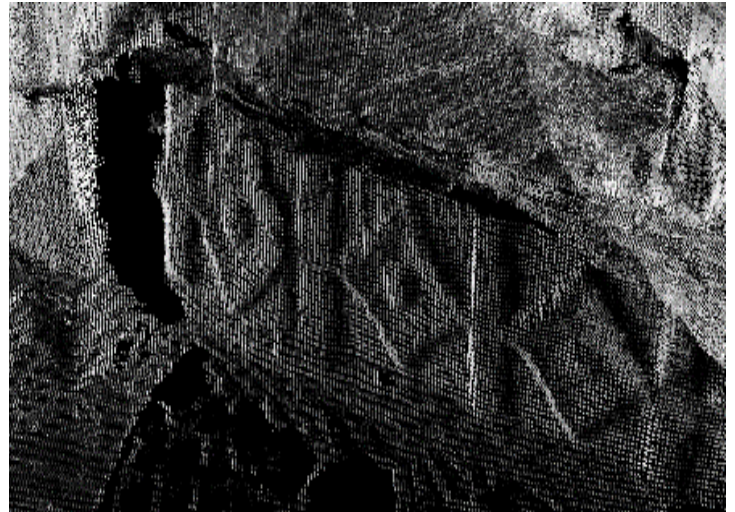
Closer look at the LiDAR model on which ASI can conduct research and create drawings for documentation. Minute details of the designs on the wall can be seen and it can be documented as it is and it will be to scale

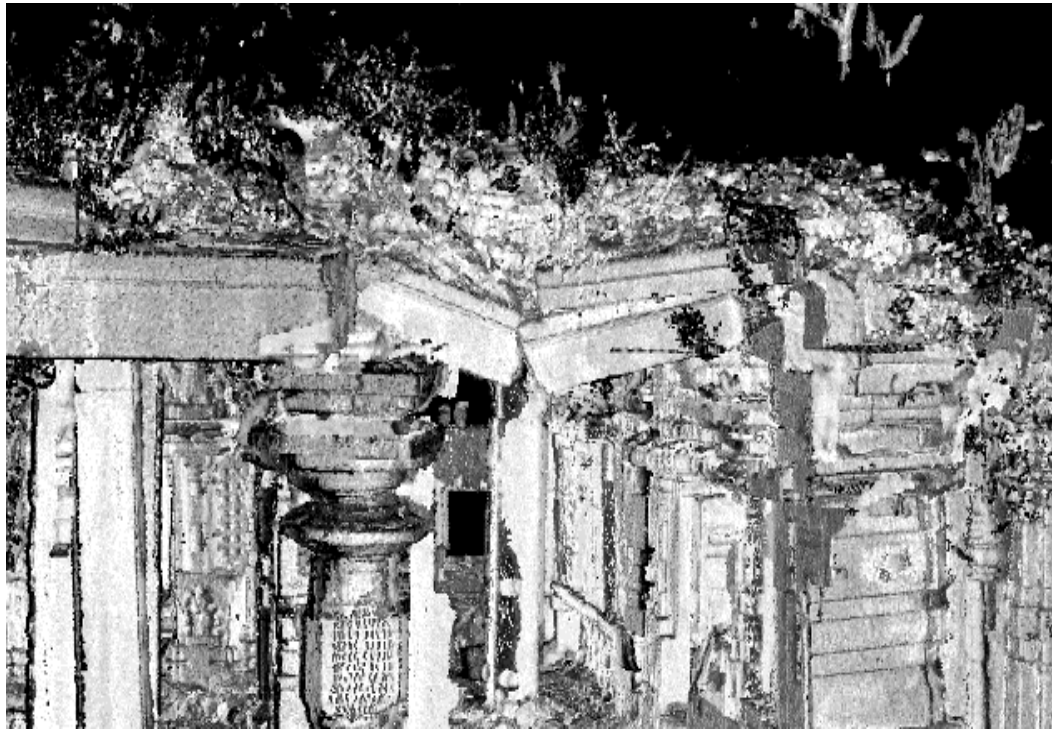
LiDAR data which can be utilized for analysis of extent of damage caused, planning of repair, material calculation and cost estimation

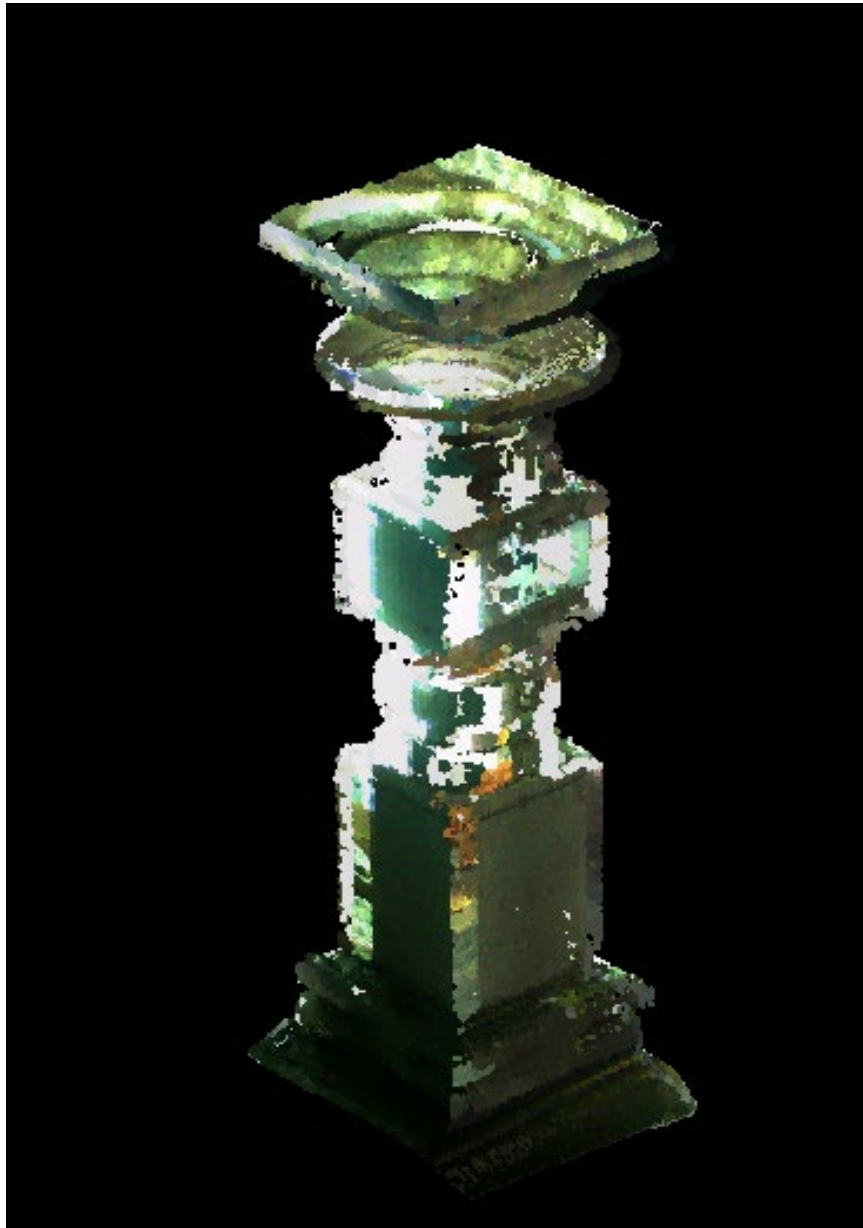
Isolating structure of importance and analyze the same for damage or documentation in 3D. Similarly, any statue or structure of importance can be modeled and documented

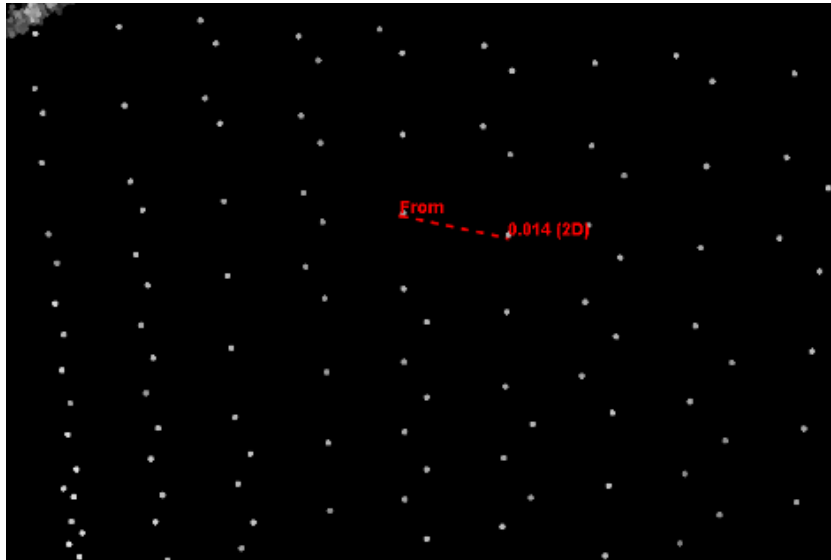
Distance between two points = 14mm (high density) which cannot be obtained by a Total Station
